Mark Cramer Inspection Services, Inc.

Building Inspection Report

Report Number: 000000
Inspection Date: 1/1/06 1:00

Address: 123 Any Street, Tampa FL
Reported Square Footage:
Approximate Age or Year Built: 2006

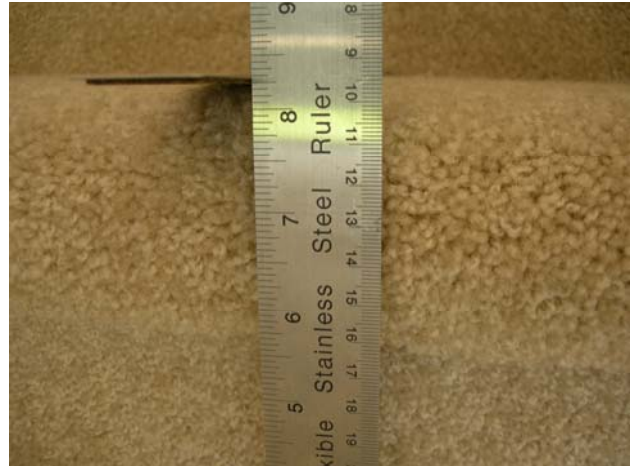
Safety Concern The bottom step at the interior stairway is 8 ¼ inches high. The maximum riser height allowed is 7 ¾" 2004 Florida Building Code, Residential reference:

R311.5.3.1 Riser height.

The maximum riser height shall be 7¾ inches (196 mm). The riser shall be measured vertically between leading edges of the adjacent treads. The greatest riser height within any flight of stairs shall not exceed the smallest by more than 3/8 inch (9.5 mm).

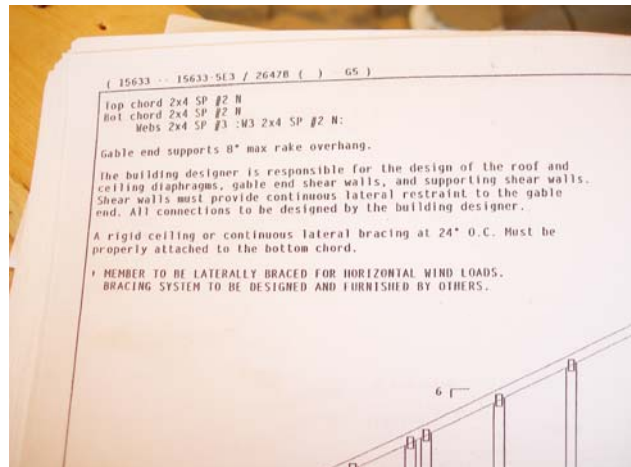
Investigate Further As reported during the April 24, 2006 framing inspection, the plans for the house show that the second story exterior wall at the living room should be constructed using 2x6 framing. This was not done. A truss was used here instead. There are no details on the plans for bracing this truss without framing (for a ceiling) at the top of the masonry wall. The building designer should specify bracing and attachment for this condition. I had some discussion with Robby Flynn regarding who should specify this bracing. He maintained that it's the truss engineer's responsibility. (This is a common misconception; I used to think the same myself.) I maintain that it's the building designer's responsibility to specify bracing here. Note that the plan for the truss states that bracing should be specified by the building designer. (See the photo.) I can't see that any bracing has been added here.

Verify that this condition was addressed by the building designer.

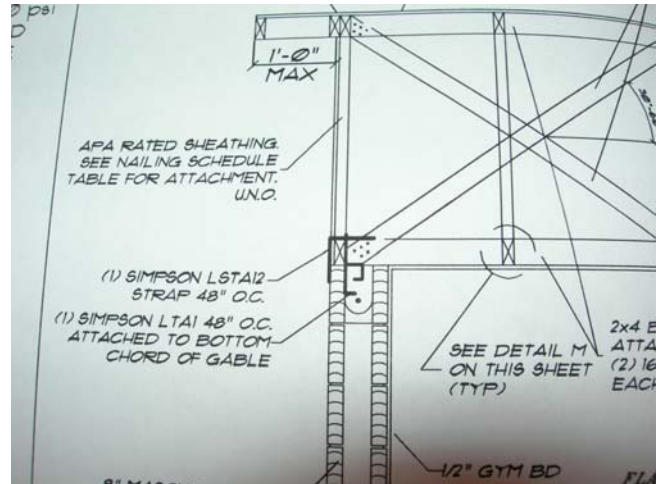
Gable end wall bracing detail from plans

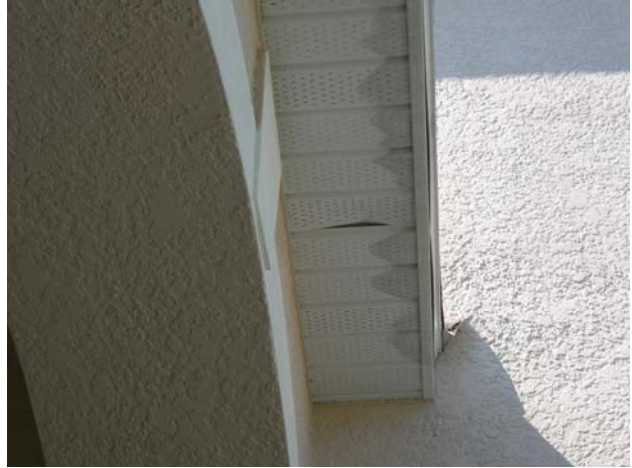
Minor Repair On the front side above the front entry, soffits are pushed up and bent.

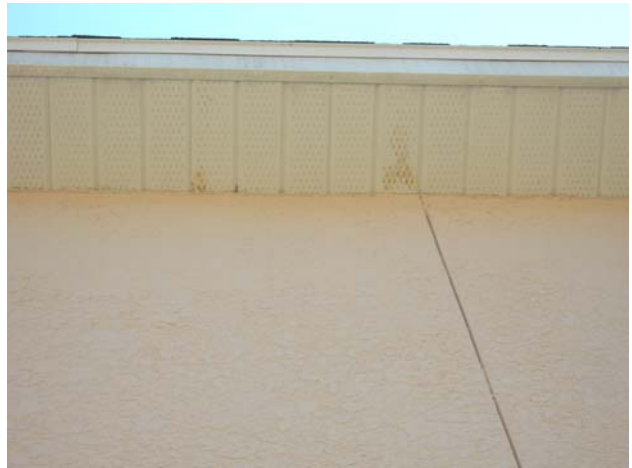
Minor Repair Paint needs cleaning from soffits on right side.

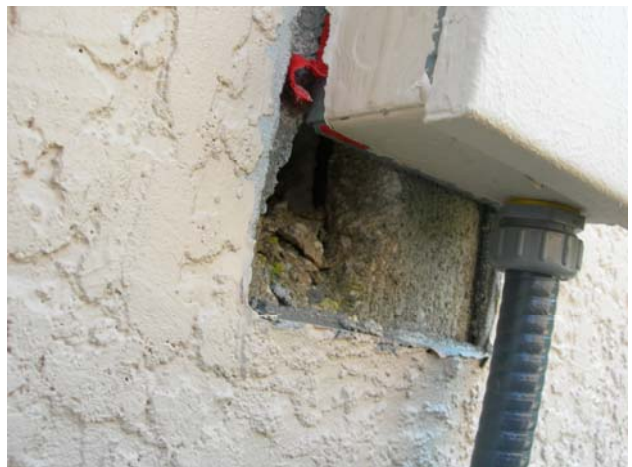
Minor Repair Stucco needs patching at condensing unit disconnects.

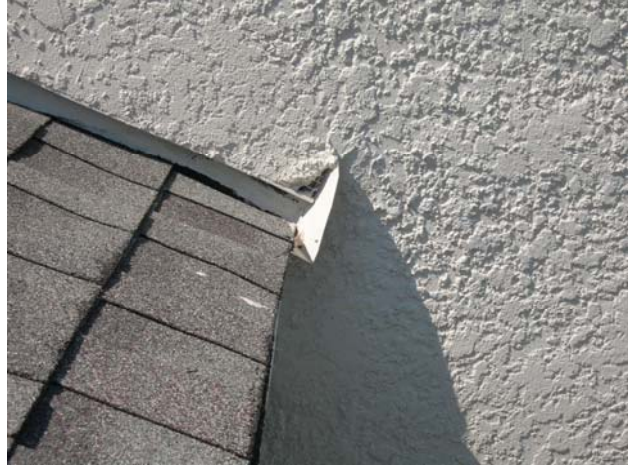
Minor Repair Wire lath that should be embedded in stucco is exposed at the sidewall flashing above the front entry.

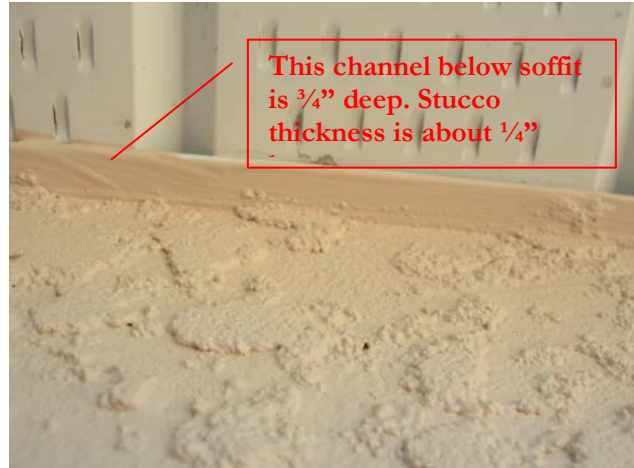
Major Repair The stucco on the wood frame second story does not meet minimum thickness requirements in the Florida Building Code. The thickness varies from slightly more than 1/2 inch to less than that. 2004 Florida Building Code, Residential reference:

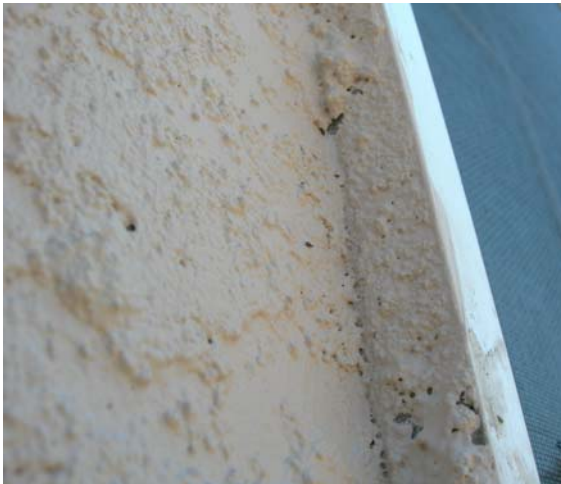
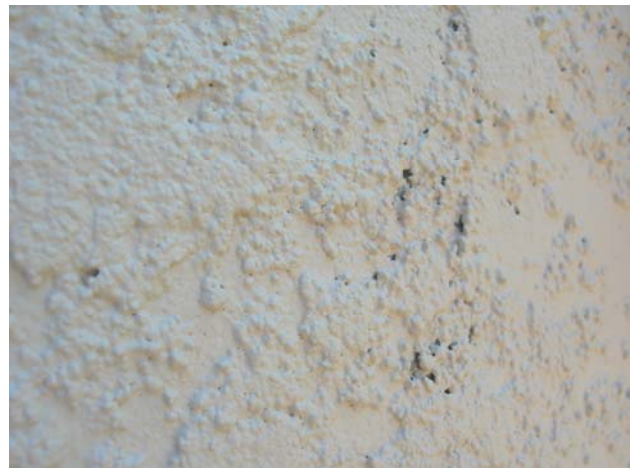
Major Repair Exterior paint is thin. Bare stucco is visible in small spots.

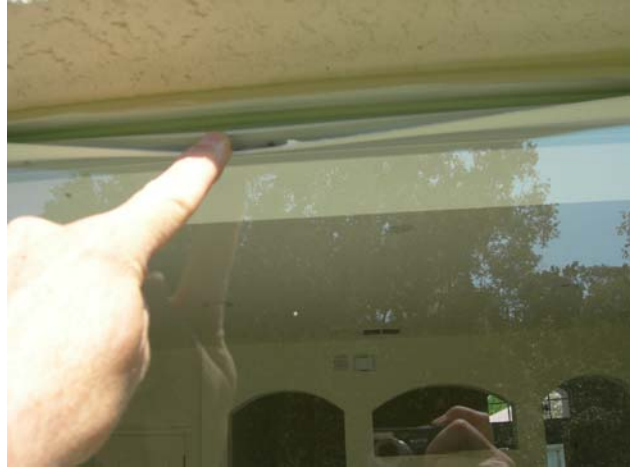
Minor Repair At the exterior of the rear family room windows, a piece of trim is loose from the window.

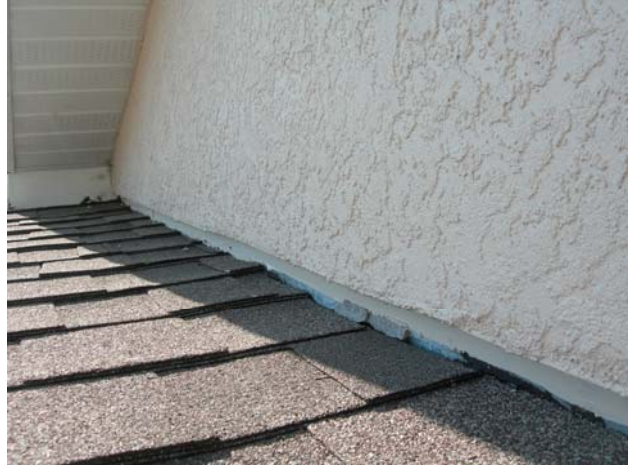
Minor Repair Roof and sidewall intersections are flashed with continuous metal rather than step flashing as required. Flashings installed in this manner are prone to leakage, usually a couple years in the future. Step flashing should be installed. 2004 Florida Building Code reference: *R905.2.8.4 Sidewall flashing. Flashing against a vertical sidewall shall be by the step-flashing method.*

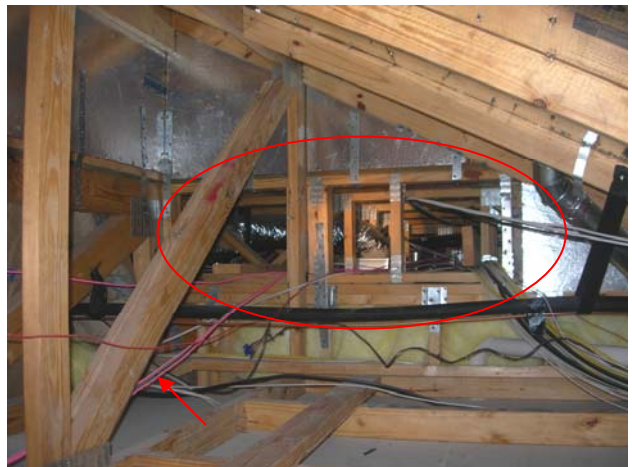
Minor Repair Openings from the garage attic to the second floor framing need to be insulated and made air tight to prevent hot attic air from entering the space between the floors.

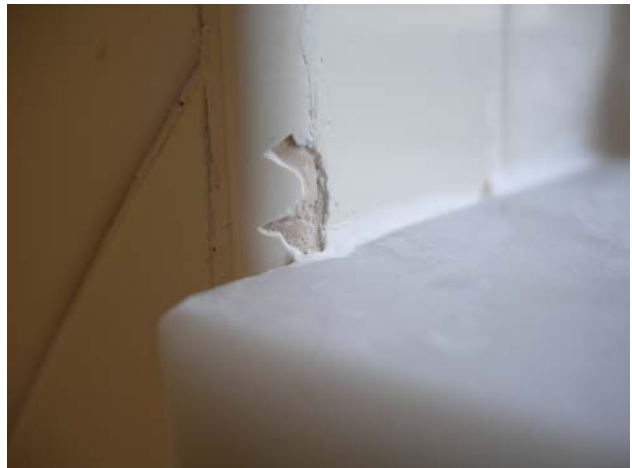
Minor Repair In the downstairs bath, a tile near the window sill is chipped.

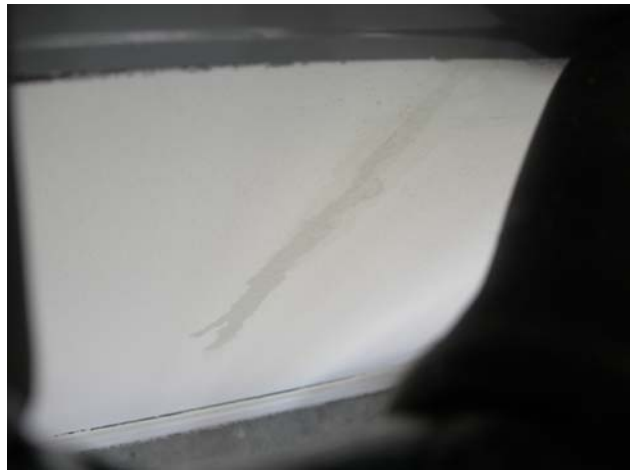
Minor Repair The garage air handler is leaking conditioned air from small openings. Condensation is present on the case and was dripping down the drywall enclosure below the air handler.

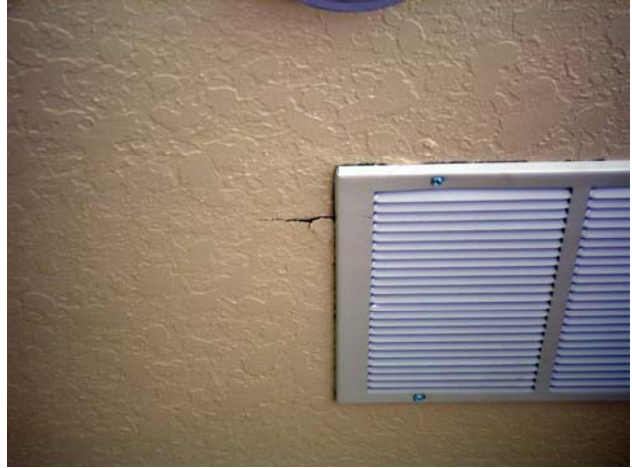
Minor Repair In the downstairs bedroom, the ceiling is cracked near the return air register.
