Mark Cramer Inspection Services, Inc.

Building Inspection Report

Report Number: 000000
Inspection Date: 1/1/06 1:00

Address: 123 Any Street, Tampa FL
Reported Square Footage:
Approximate Age or Year Built: 2006

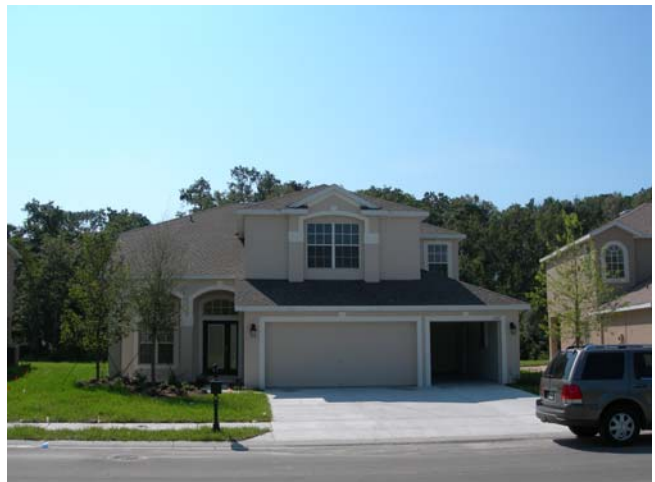
Investigate Further As reported during the April 24, 2006 framing inspection, the plans for the house show that the second story exterior wall at the living room should be constructed using 2x6 framing. This was not done. A truss was used here instead. There are no details on the plans for bracing this truss without framing (for a ceiling) at the top of the masonry wall. The building designer should specify bracing and attachment for this condition. I had some discussion with Robby Flynn regarding who should specify this bracing. He maintained that it's the truss engineer's responsibility. (This is a common misconception; I used to think the same myself.) I maintain that it's the building designer's responsibility to specify bracing here. Note that the plan for the truss states that bracing should be specified by the building designer. (See the photo.) I can't see that any bracing has been added here.

Verify that this condition was addressed by the building designer.
