Mark Cramer Inspection Services, Inc.

Building Inspection Report

Report Number: 90002785

Address: 123 Any Street, Clearwater FL 33785

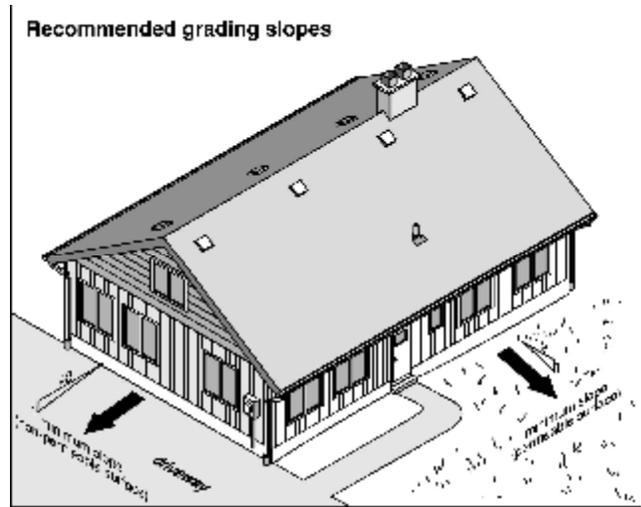
Grading is adequate in most areas. Minor adjustment is needed in some locations to divert water away from the foundation.

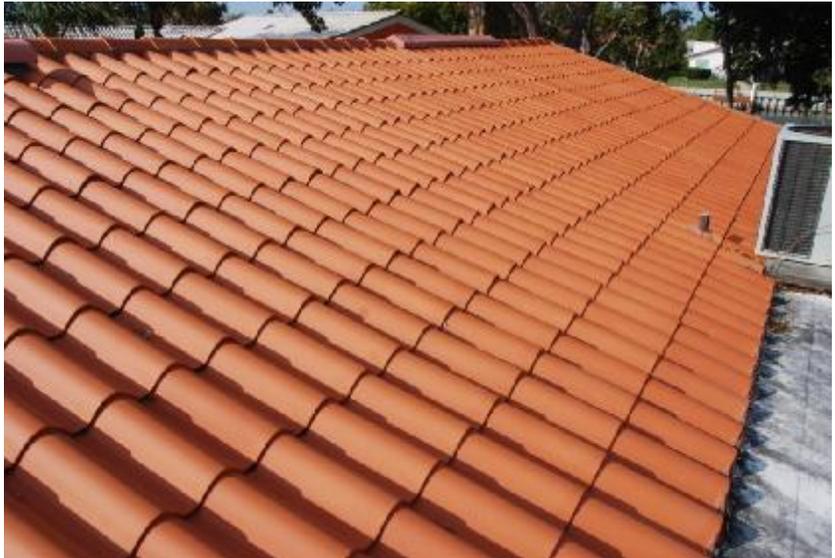
The tiles appear to be well fastened and aligned. None were broken or cracked. No evidence of slippage or movement of the tiles or sub-roof was observed. Flashings appear intact. Valleys are in adequate condition. The metal edge is intact. The inspector was able to get a good look at most of the underside of the roof sheathing while in the attic. No signs of active leaks were observed. The roof appears to be watertight at present.

We recommend that you ask the seller about the presence of any roof leaks, including past leakage. If repairs are needed, a licensed roofing contractor should make them.

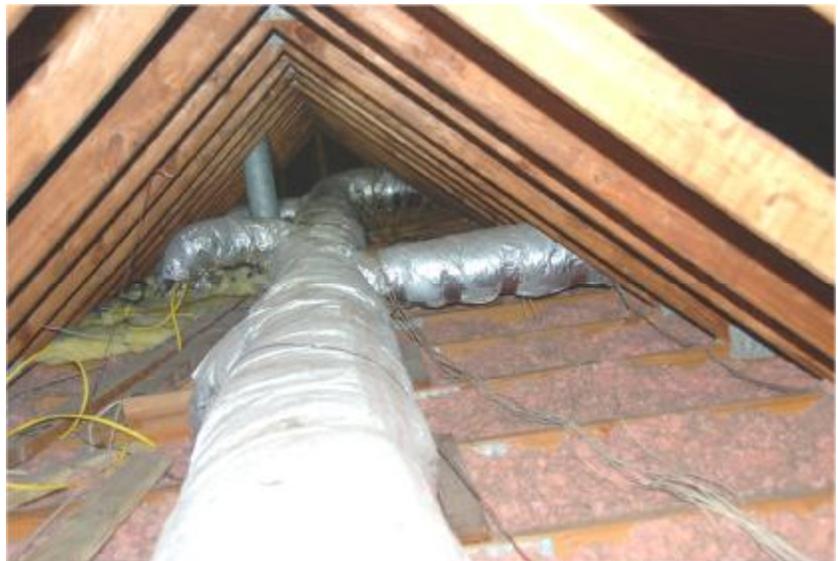
The condition of readily visible elements in the attic appears adequate except as noted elsewhere in the report. Roof sheathing and framing were examined and probed for signs of deterioration in limited areas. None were found except as noted elsewhere in the report.

We saw no evidence of leakage in the readily accessible areas.

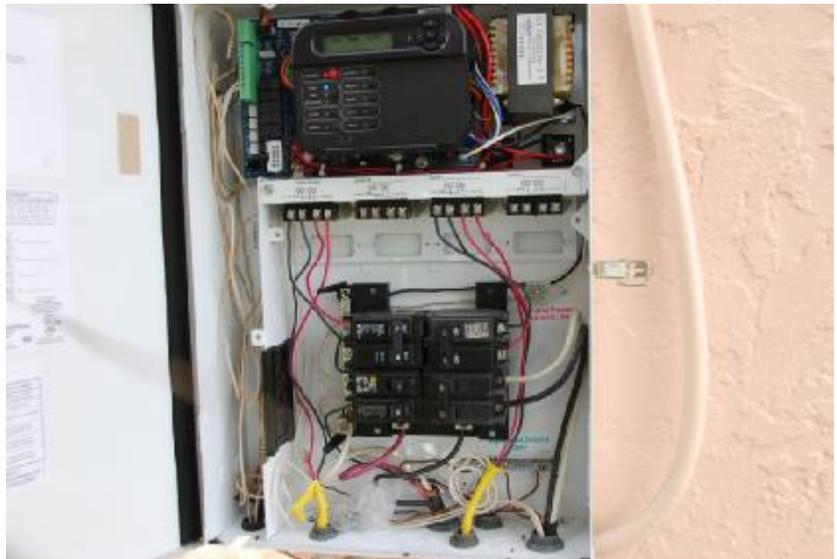
GFCI devices tested functional using a testing device. GFCI devices are not installed in all recommended locations. Upgrading is recommended.

Metal gas piping is not bonded. See repair list at end of report.

The pool equipment is not bonded properly. See repair list at end of report.
